Orange County, California restaurant lateral at intersection with sewer main, prior to pre-trial cleaning. The main had previously been cleaned to some extent every 30 days.

The above images were taken from videos of the inside of an Orange County, California sewer main at the point where the main intersects with a lateral line emanating from a high-volume full-service restaurant. A BESTech Biofeed® system was installed in the restaurant (which does not utilize a grease interceptor) on January 15, 2005. The videos were recorded periodically between January and July 2005 as part of a study, underwritten by several Orange County municipalities, to determine the effectiveness of various drain line maintenance products, including BESTech Biofeed.

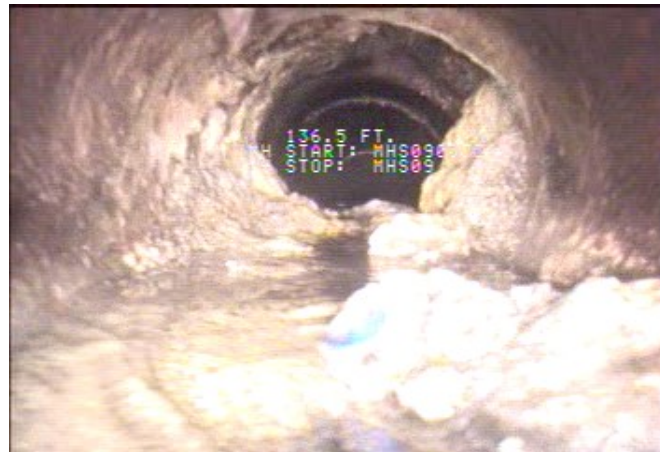
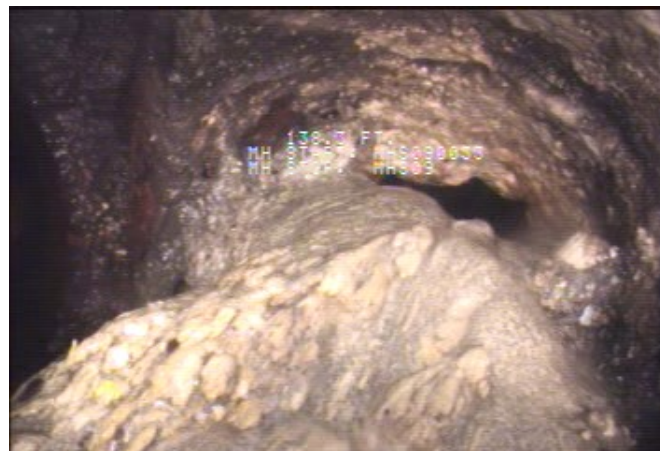
JANUARY 11, 2005

**SEWER MAIN
(LATERAL AT
RIGHT OF
EACH IMAGE)**

**LATERAL LINE
(AS VIEWED
FROM SEWER
MAIN)**

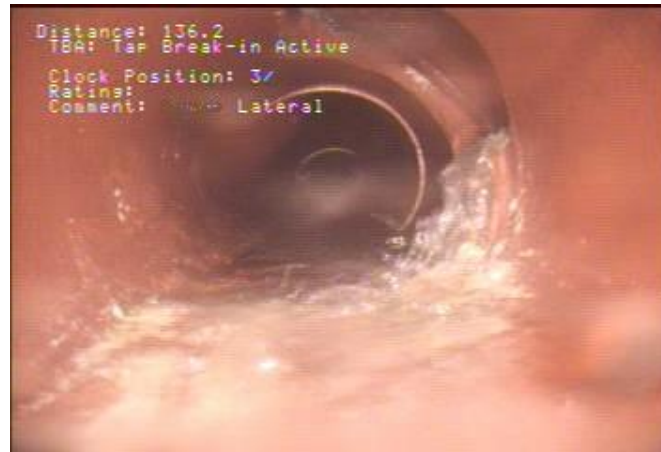
JANUARY 13, 2005

Same Orange County, California restaurant lateral at intersection with sewer main. Images captured immediately after cleaning of main, two days prior to installation of BESTech Biofeed® system.

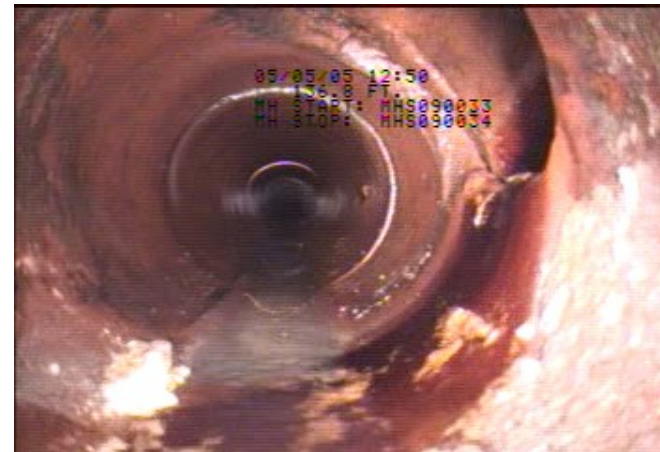
JUNE 5, 2005

Same Orange County, California restaurant lateral at intersection with sewer main (143-day build-up). Images captured 141 days after installation of BESTech Biofeed system.
